May 10, 2022

Mr. Dennis Todd
City of Lake Waukomis
1147 NW South Shore Drive
Lake Waukomis, MO 64151

Re: Lake Waukomis Dam/Abutment Seepage Project
Affinis Job No. 21-0909-01
DRAFT Seepage Assessment Report

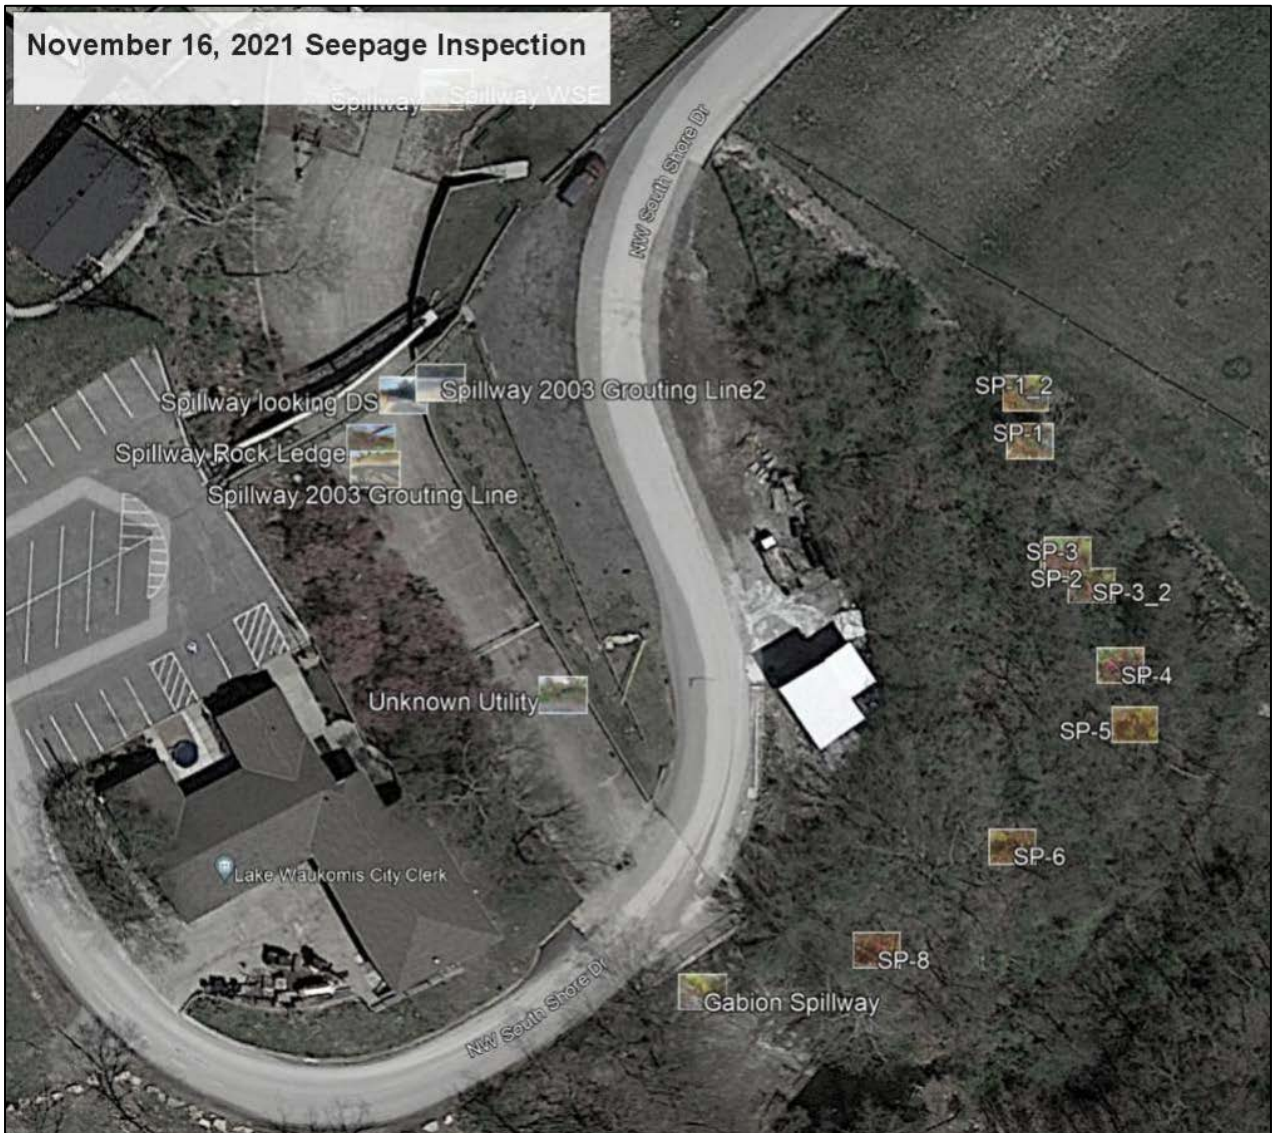
Figure 2-West Abutment Seepage Locations

The West abutment seepage locations were numbered (SP-0 to SP-8), staked, and flagged to be surveyed for vertical and horizontal locations (see Figure 2). The West seepage elevations ranged from elevation 910-ft to 904-ft. The seepage flow was estimated at each identified seepage location. In general, the seepage decreased from SP-0 to SP-8 (decreasing moving East to West). The West abutment weir was measured, and discharge flows were calculated for the V-notch weir. See Figure 7 for a summary of the estimated seepage and weir flows.

Figure 2 shows the West abutment seepage locations found during the boots-on-the-ground inspection.

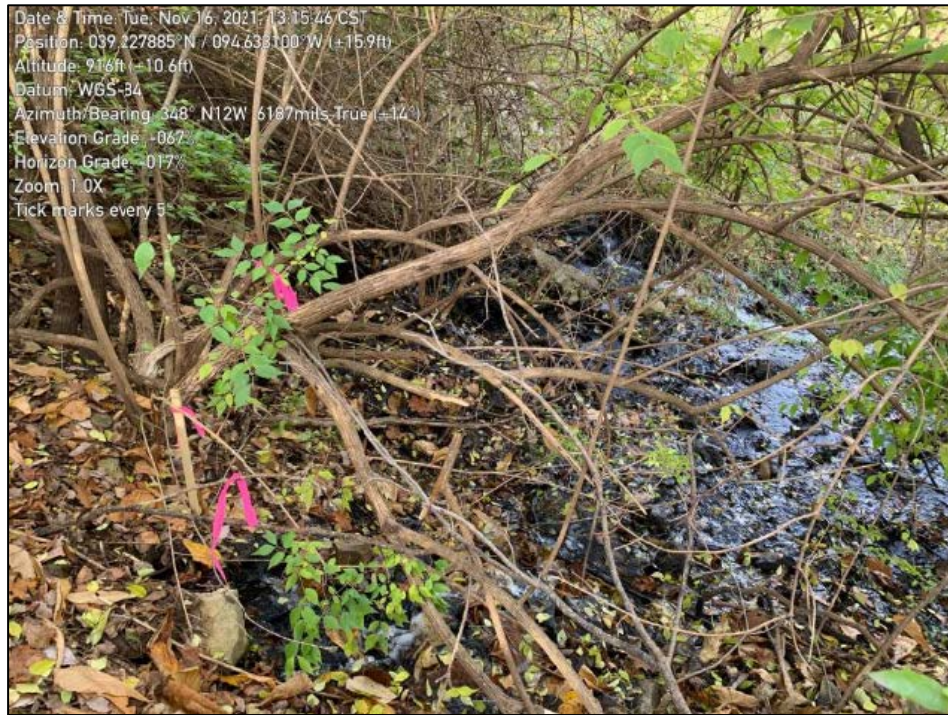
Figure 3- Seepage Point #1

Figure 3 is a photo Seepage Point #1 where the highest seepage flows were estimated.

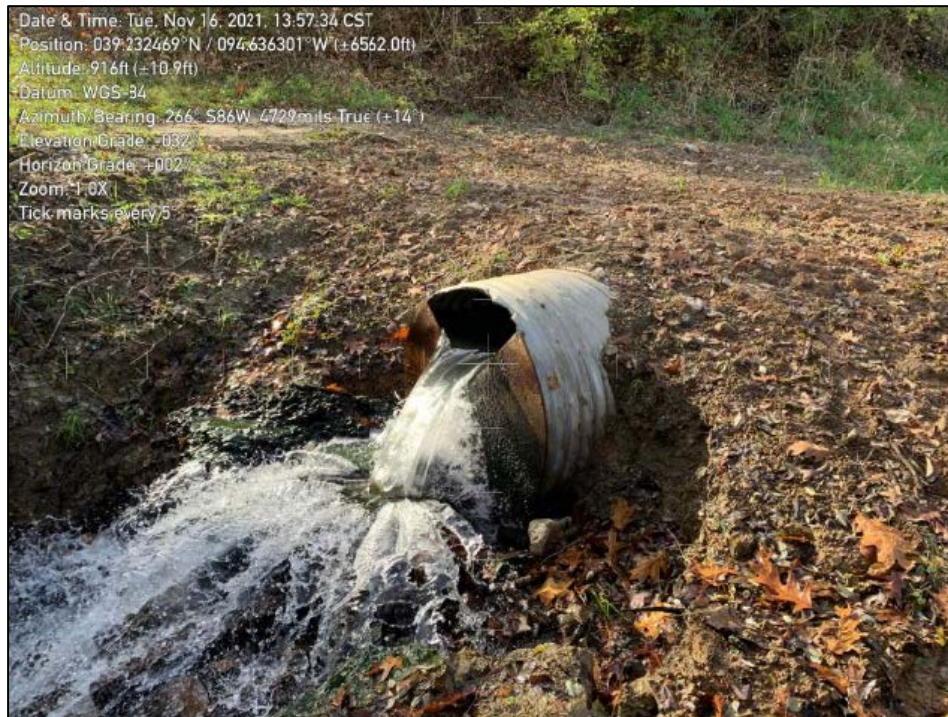
Figure 4- West Abutment Seepage Weir

Figure 4 is a photo of the West abutment seepage weir.

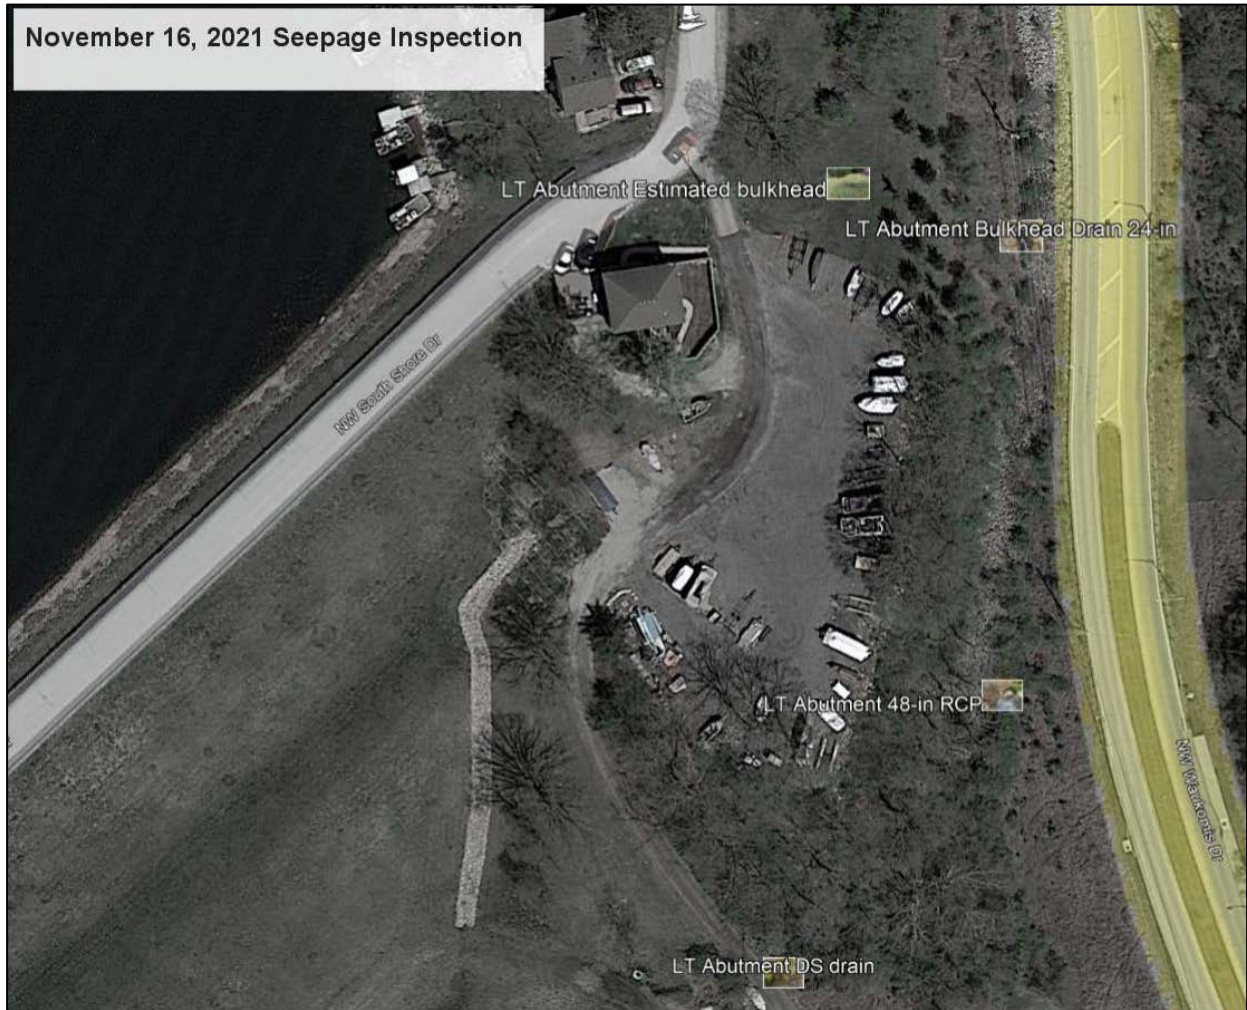
Figure 5- East Abutment Seepage Location

The East abutment inspection found only a single location for visual seepage coming from the 24-in HDPE (see Figure 5). The East abutment looked dry and free from indicators of seepage. A 48-in RCP had some discharge that was coming from inside the pipe as well as from what appeared the granular bedding material below the pipe. Flow from the 48-in RCP is likely from upstream drainage. The approximate seepage discharge elevation from the upstream end of the HDPE pipe is 917-ft based on as-built drawings from the 2012 bulkhead construction.

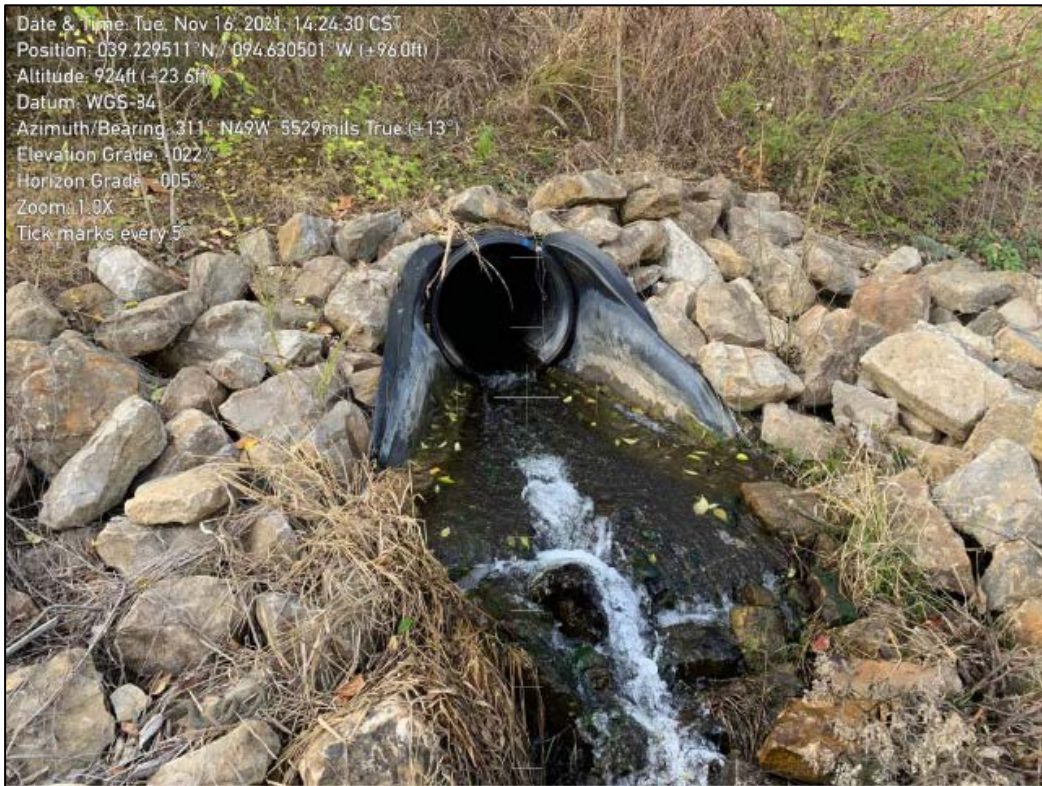
Figure 6- East Abutment Seepage Discharge from 24-in HDPE

Figure 6 shows the East abutment seepage location found during the boots-on-the-ground inspection. The East abutment inspection only found one seepage location to be discharged from the left abutment bulkhead drain (24-in HDPE pipe). The HDPE does not have a weir for measuring discharge flows. However, the depth of the pipe was measured, and an estimated flow was calculated. See Figure 7 for the estimated pipe flow.

Figure 6 is a photo of the East abutment seepage from a 24-in HDPE pipe.

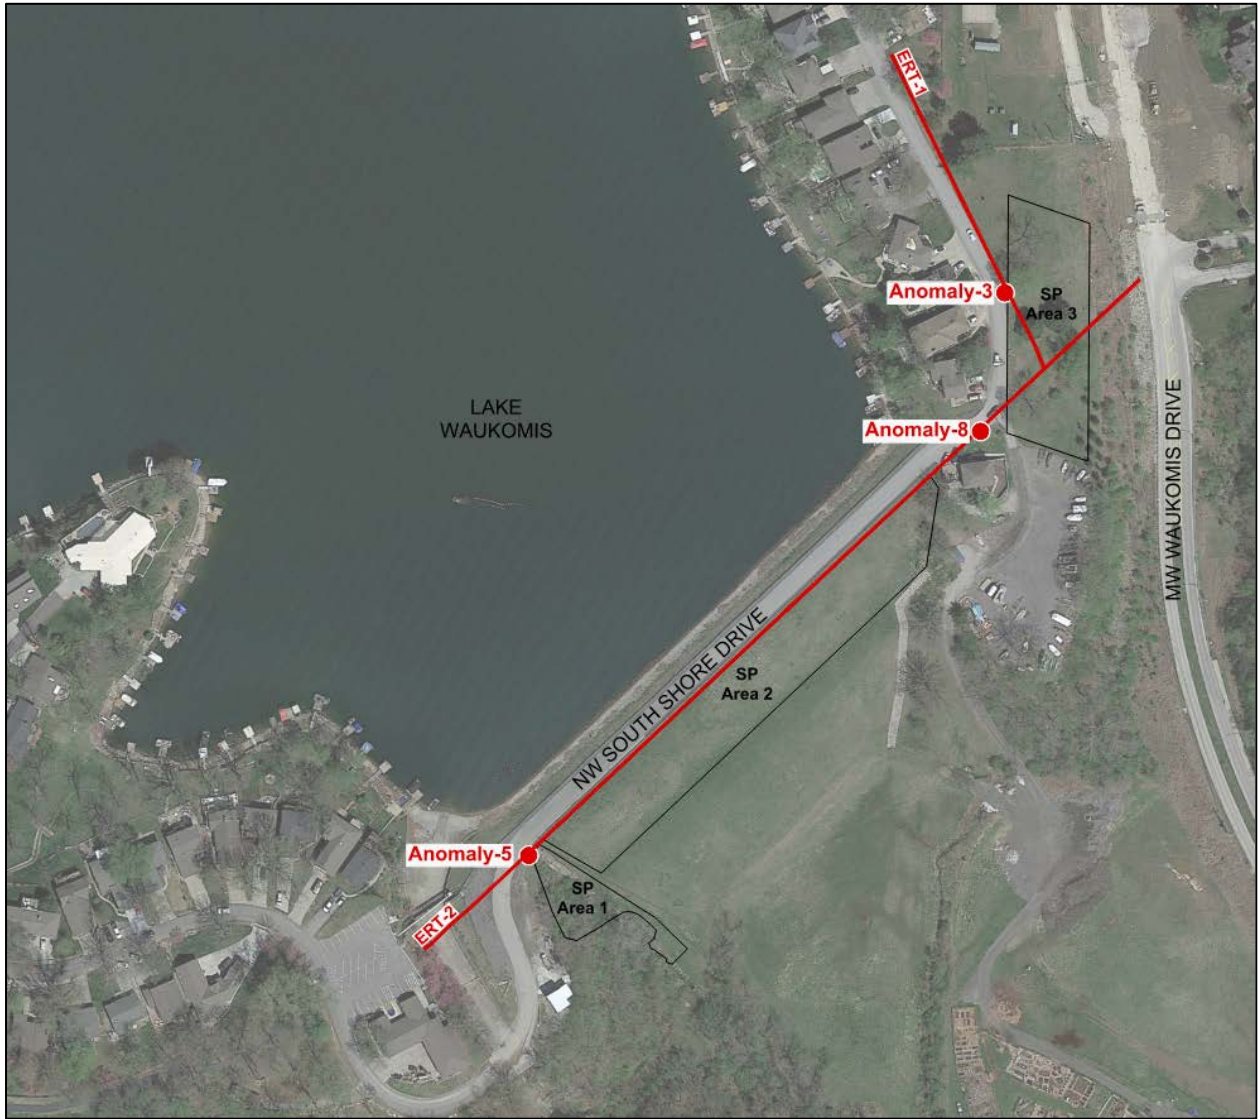
Figure 9- Aerial View Geophysical Survey Lines

The ERT and SP effort generally identified eight (8) anomalous areas of suspected seepage. The locations of these suspected areas of seepage are depicted in Figures 9, 10, 11 and 12. Of these eight (8) anomalies and following a review of the resistivity results and the general conditions in these areas, Anomalies 1, 6, and 7 were not deemed to be of any significant concern with regard to abutment seepage. These anomalies were eliminated from consideration with regard to drilling and sampling, primarily due to possible “false indicators” due to electrical interferences caused by metal guard rails and other similar features.

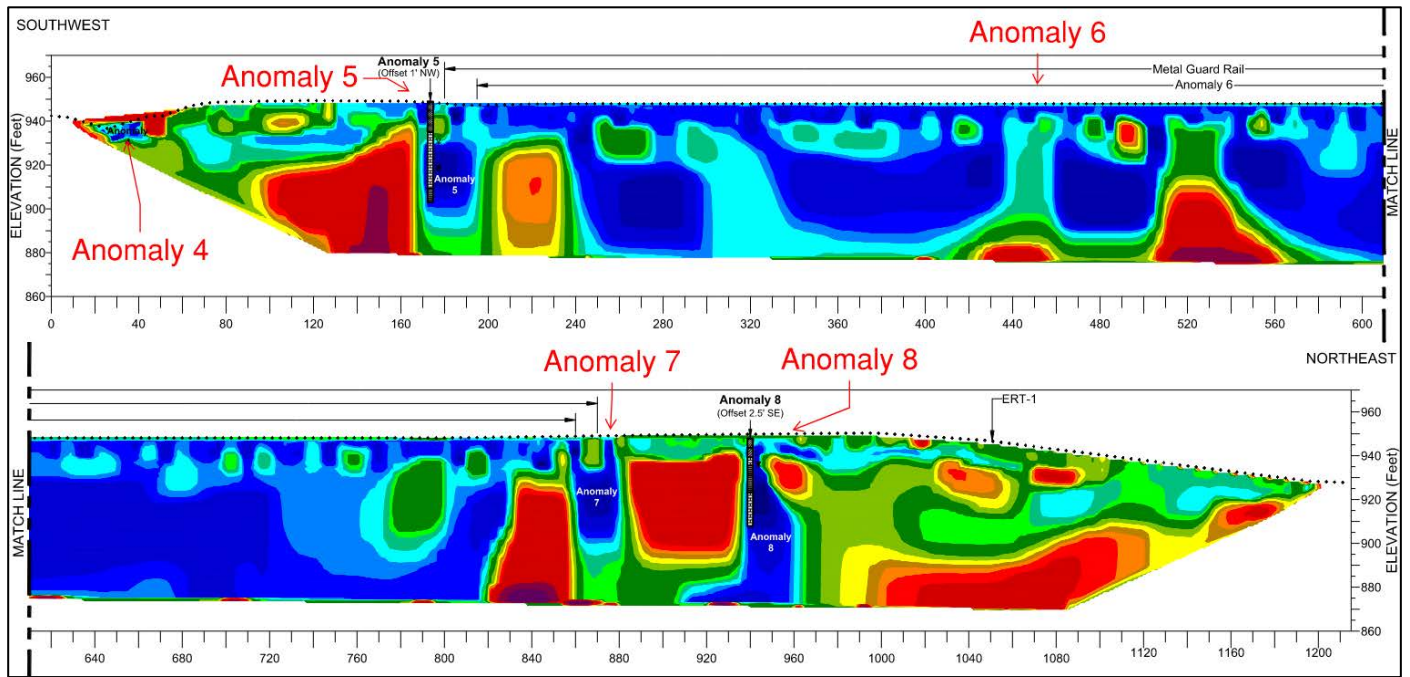
Figure 11- Geophysical Survey - ERT Line 2

Of particular interest were Anomalies 4 and 5, which were located in areas of the West abutment that had been the focus of previous/historical grouting programs. Both of these areas were grouted using inclined grout holes (spaced at 5-10 feet), likely to intercept vertical joints or features in the lower bedrock units – the Captain Creek Limestone below the spillway (Anomaly 4) and the Spring Hill Limestone in the West abutment (Anomaly 5). A review of the orientation and spacing of the grout holes at both locations (see Figure 13) indicates possible “windows” in the grout curtain at both locations, thereby indicating the need to possibly implement a grouting program with more closely-spaced grout holes.

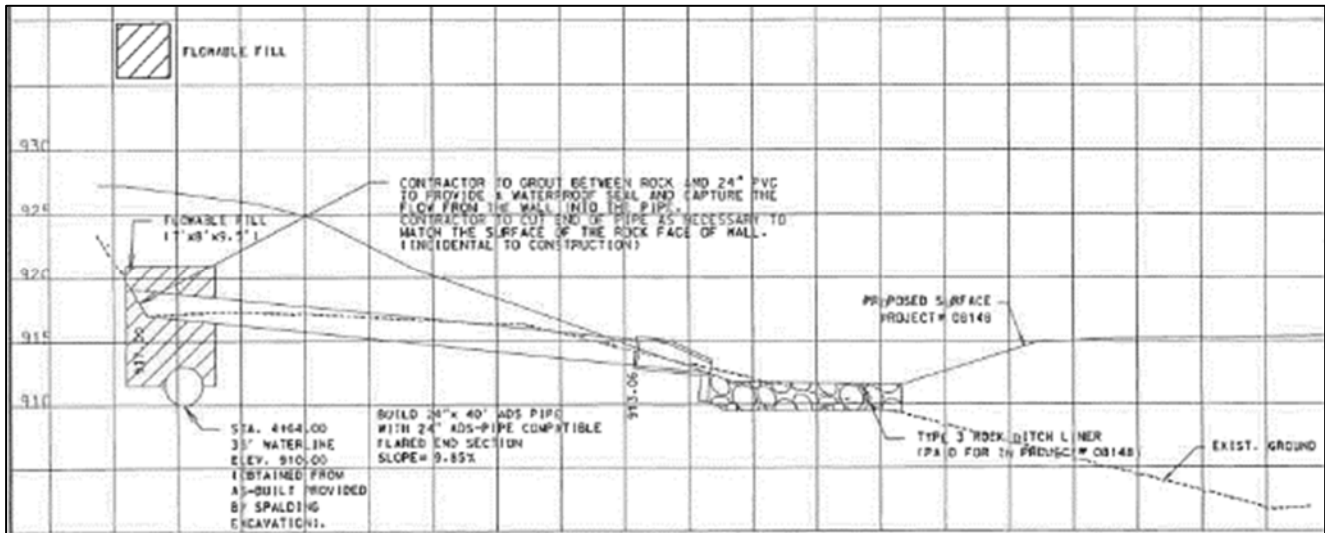
Figure 14- East Abutment Seepage Buried Bulkhead

With regard to the East abutment, an evaluation of Anomaly 2 would indicate that an existing buried utility of unknown origin may have been identified by the ERT. Anomaly 3 appears to be related to a West-to-East reservoir seepage path through bedrock that is ultimately being intercepted by a buried bulkhead located between the dam and NW Waukomis Drive (see Figure 14). This buried bulkhead was constructed in 2012 by a contractor to control excessive seepage water emanating from a vertical trench wall in a bedrock excavation for a storm sewer pipe placed along the West side of NW Waukomis Road. Anomaly 8 suggested a very discrete, vertically-oriented seepage path that is likely related to a vertical feature/seam within the subsurface bedrock profile.
