SUMMARY REPORT FOR THE CITY OF LAKE WAUKOMIS

SANITARY SEWER SYSTEM REPAIR PLAN

By: Jay Norco, P.E. – North Hills Engineering, Inc. November 24, 2021

PHOTOS OF GENERAL FINDINGS – Lake Waukomis Sanitary Sewer System

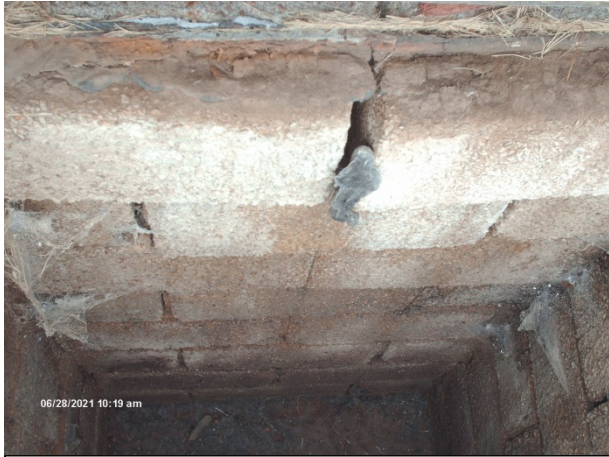
Typical rectangular block manhole. Mortar is gone and wall is heaved.

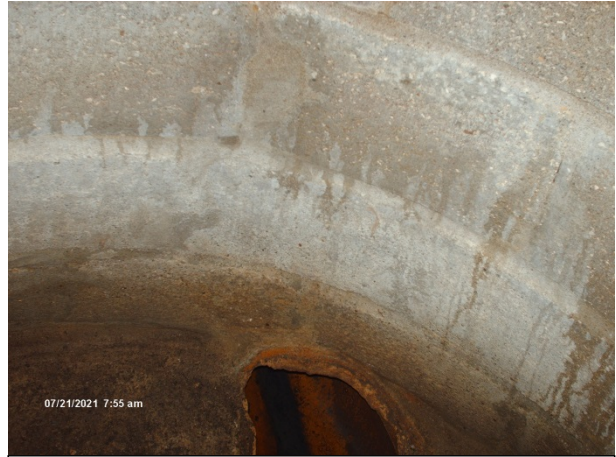
Typical round block manhole. Mortar is soft but wall is stable, can be rehabbed by lining.

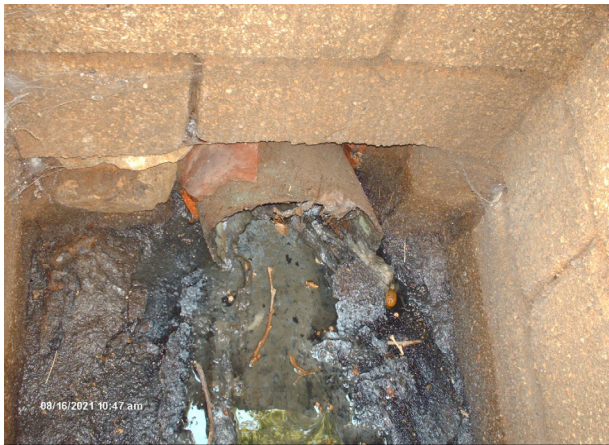
Rect. block manhole. Mortar is gone, holes allowing soil and water to enter.

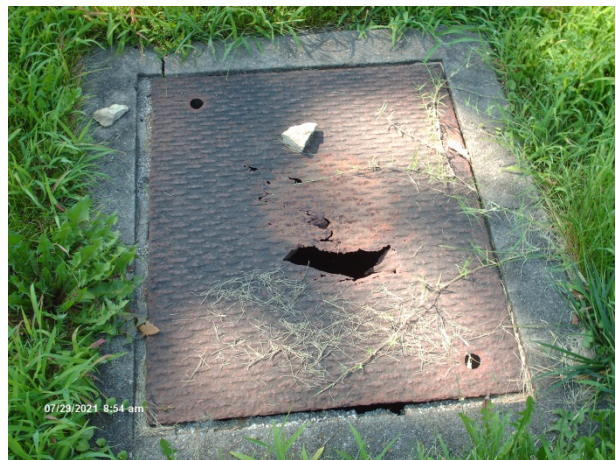
Rect. block manhole. Loose fitting lid, rusted through. Safety concern.

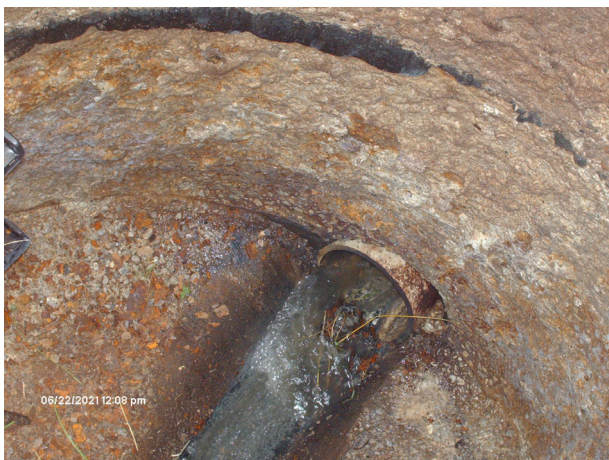
2. About 12 percent of the manholes show damage from microbially induced concrete (MIC) corrosion that results from hydrogen sulfide gas. Most of these are in the lower sections of the system near the KCMO connection or just downstream of the LW City pump stations. These corroded manholes also can be repaired in place.

Newer pre-cast conc. Manhole, with MIC corrosion from H₂S gas. About 1-inch gone.

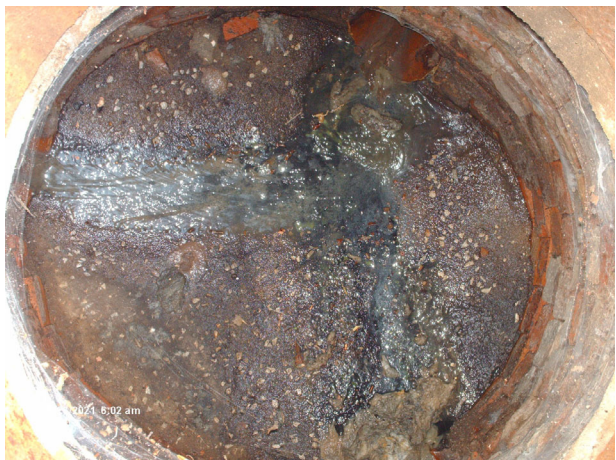
Brick manhole has no bench (channel in bottom). Causes debris to clog, and odors.

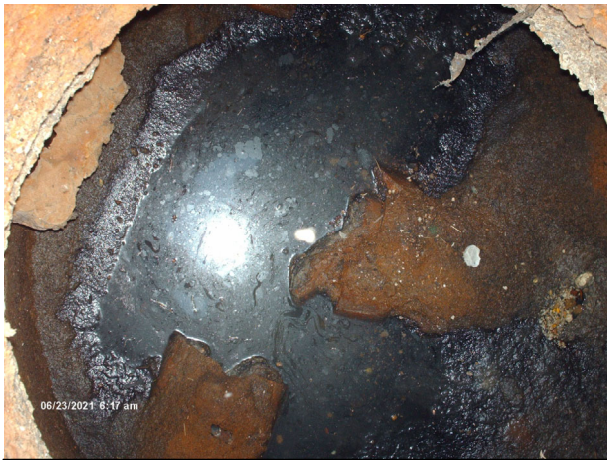
Pipe geometry poor, no bench, reduces capacity, creates back-ups.

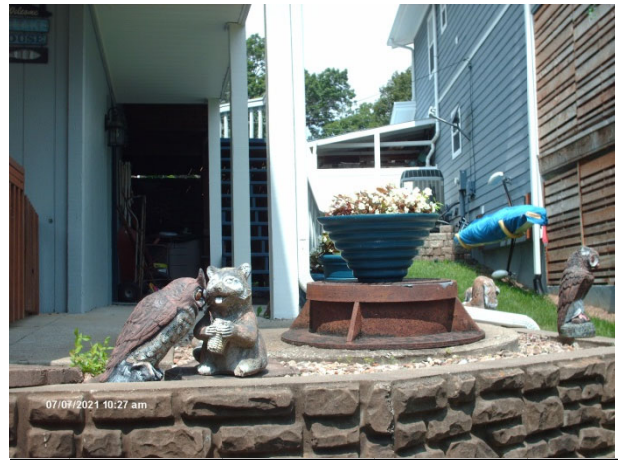
Manhole surrounded by walls, landscaping. Difficult access.

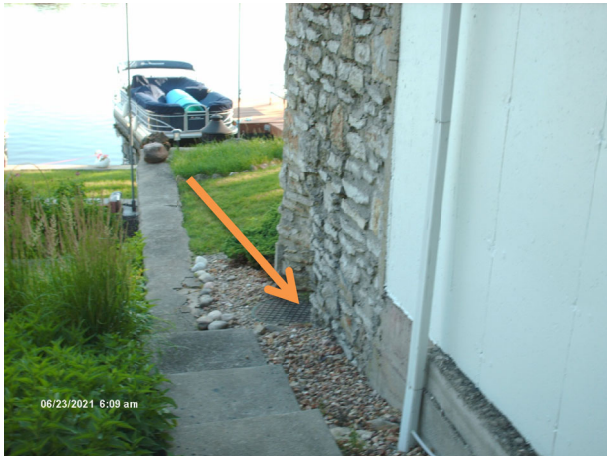
Masonry porch built over manhole. Nearly impossible to excavate here.

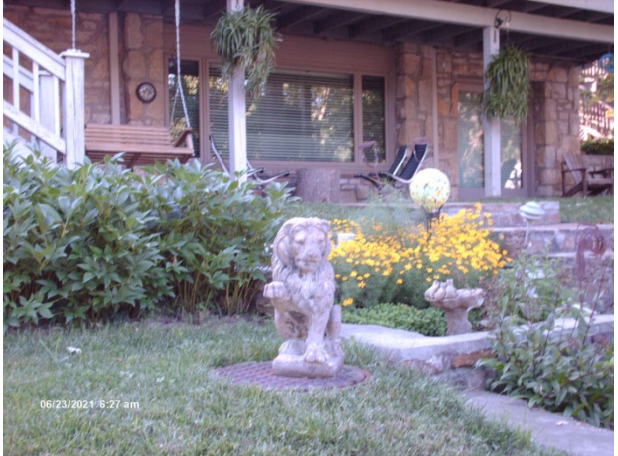
5. The forcemain from the 900 block pump station is rusted cast iron and should be replaced within 5 years. Also, in heavy rain events the discharge from this station causes the receiving sewer manhole to overflow into the lake. This occurs 4-6 times each year. The recommended solution is to lay an extension of this forcemain further down the lake, reconfigure the discharge geometry, and improve the capacity of the receiving sanitary sewer.

Manhole S09. Lid and statue are blown off from 900 Block Pump Station discharge, flows to lake.

Replace 8" iron forcemain across lake, using 8" HDPE, about 300 LF	1	LS	80000	\$	80,000
Replace 900 Block Forcemain, re-align to move discharge point further east: 8-inch PVC or HDPE, open cut bury.	760	LF	80	\$	60,800
Reconfigure MH S06A and pipe intersection, at #1087 S. Shore Dr.	1	LS	25000	\$	25,000

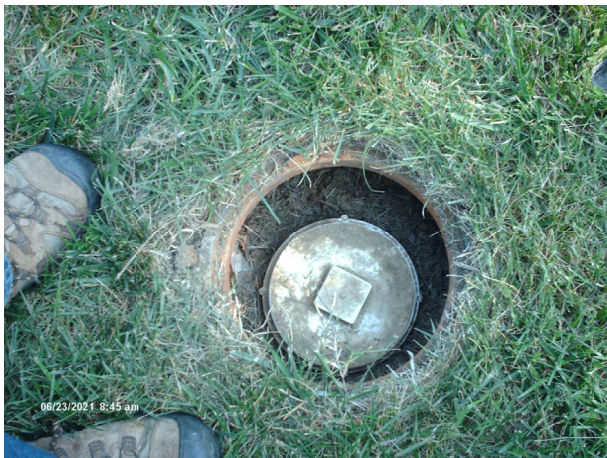
Small PVC cleanout on main sewer line. Need to replace with manhole.

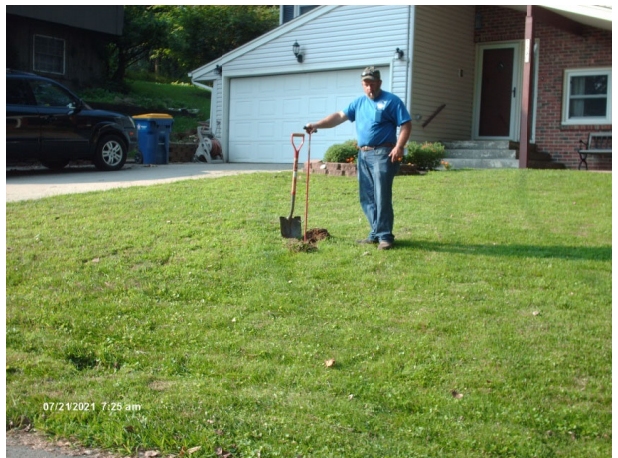
Manhole located, buried 18" deep in yard. City staff can raise to grade.

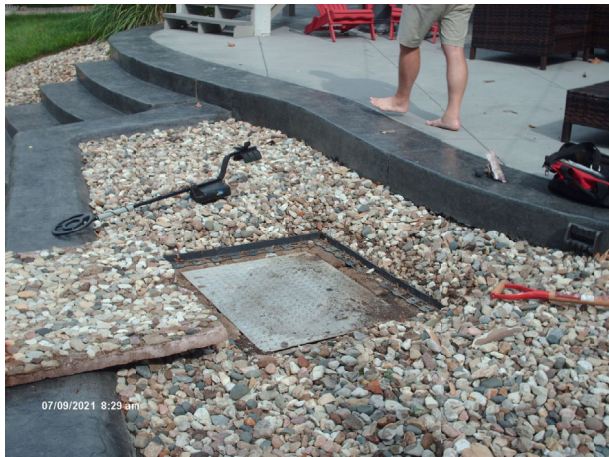
Ingenious camo'd cover by homeowner, rocks glued to board... But new MH needed, raised to grade.

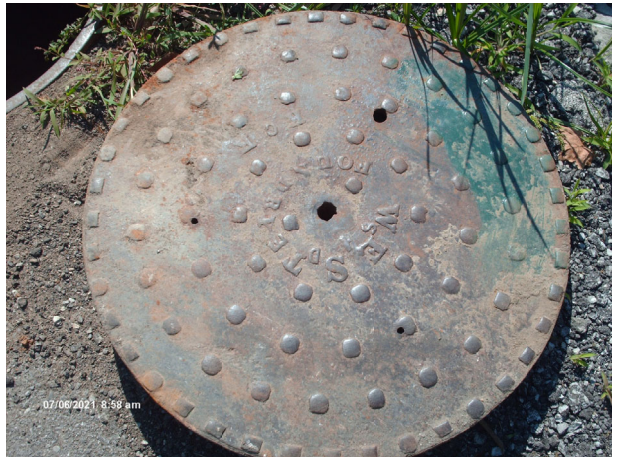
Some lids have vent holes, allow water inflow, this one in ponding area of intersection. Replace.

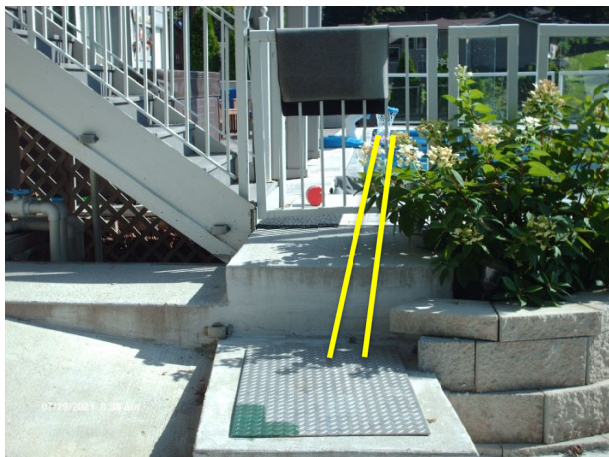
Sewer line under pool. Manhole under deck and wall. Repairs will be interesting...

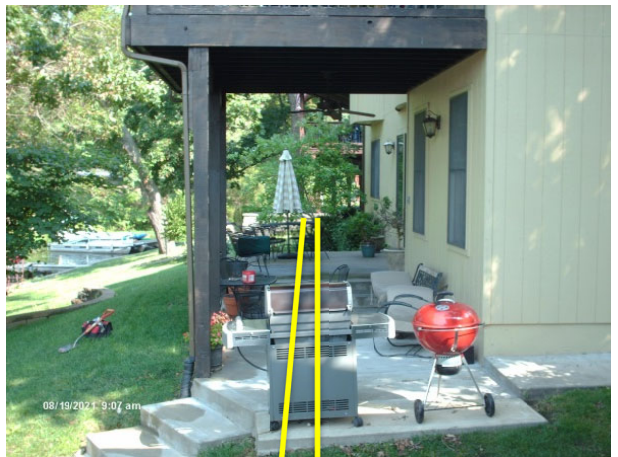
Sewer runs below patios and decks. Hopefully excavation not required....

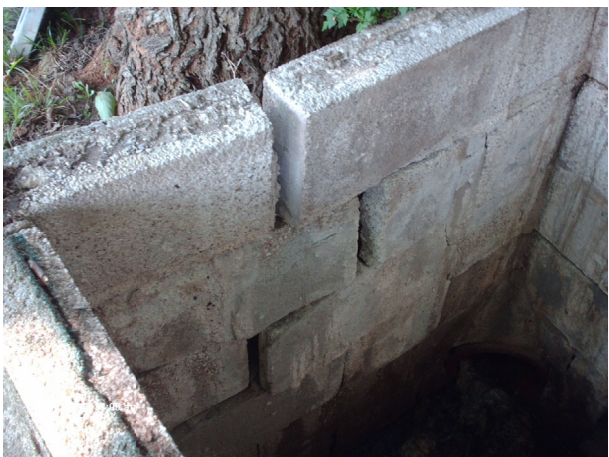
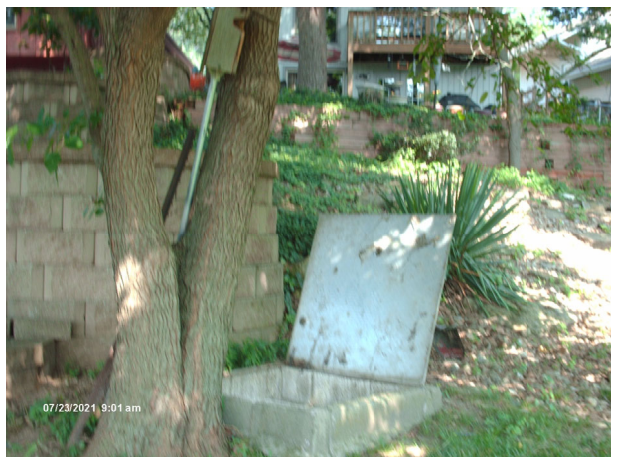
Rectangular block manhole badly heaved by adjacent retaining wall.

View of heaved MH, picture at left. Costly to replace due to wall and landscaping.
